# Application Note 1034

## MXZ Branch Box Applications with Blue Diamond Pump

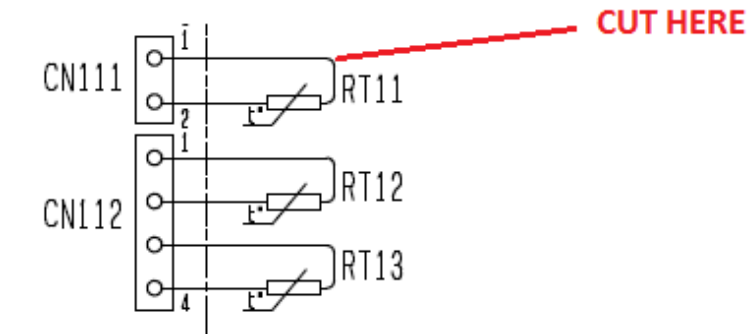
Wire the NC safety circuit from the pump in series with one of the indoor thermistors. Best practice is to solder the connection, or use butt splice connector.

**\*\*FOR APPLICATIONS USING THE APPLICABLE MODELS, DO NOT BREAK THE S1, S2 or S3 WIRE TO THE INDOOR UNIT OR ERROR WILL OCCUR\*\***
